**ProCULTHER-NET**

PROTECTING CULTURAL HERITAGE  
FROM THE CONSEQUENCES OF DISASTERS - NETWORK

# TECHNICAL BULLETIN

ISSUE #2. June 2023

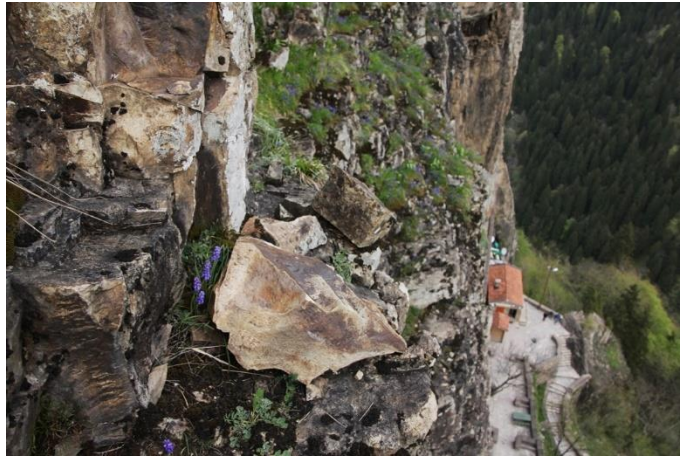
*Hillside rock cleaning © MoCT*

The works started with the cleaning of the slopes and precautions were taken against the pieces of rock that could fall on the Monastery's entrance way. The free surface was cleaned to a large extent on the rocky surface, the stones that were about to fall were removed by breaking them, and the stones that could be recuperated were fixed. A rock barrier was built for the stones that could fall from above.

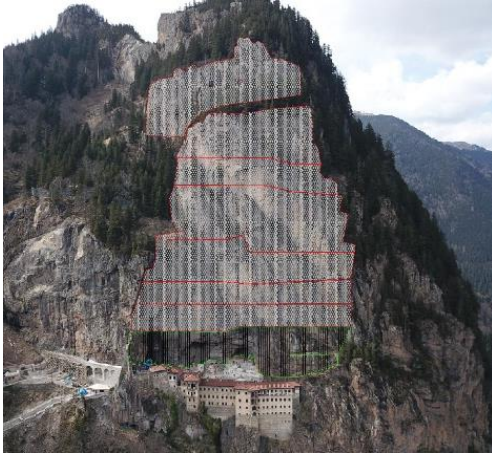
While designing the rock and stone fall project; Influencing factors such as lithological description, definition of discontinuities, morphological structure of the slope, definition of possible stability problems, frequency of occurrence of the problem, seismicity of the area, environmental factors, priority of protection and lifecycle of the protection operations implemented were taken into consideration. Scaffolding which had a minimum contact with the structures was built to protect the structures in the monastery from rockfalls during the works. In addition, a moisture barrier was used to protect the frescoed surfaces from environmental conditions. Small pieces of rock carry a high risk of falling rocks and stones due to snow, water, wind effect, animal movements and plant roots. Personnel working in the slope area are also more likely to be harmed. Therefore, the entire slope area was covered with steel wire.

The risky blocks identified during the project phase were fixed simultaneously with the covering process. In these areas, respectively; steel rope connection anchoring with bolts, frame rope construction, high-strength steel wire mesh covering, horizontal steel rope line and IBO bolts fixing to the bedrock productions were made. A map of the slope area was prepared to describe the anchorage and containment system and containment measures for each major block.

*Slope area steel wire application ©MoCT*

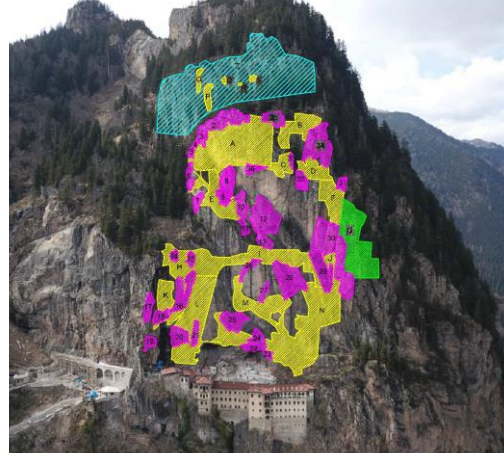
*Slope Area Map © MoCT*

It was recommended to fix the large rock blocks with specified risk 500/550 with anchors 32 mm in diameter and 4.0 - 6.0 m long. Anchors were mounted on rocky blocks with vertical fractures with intermediate roughness.

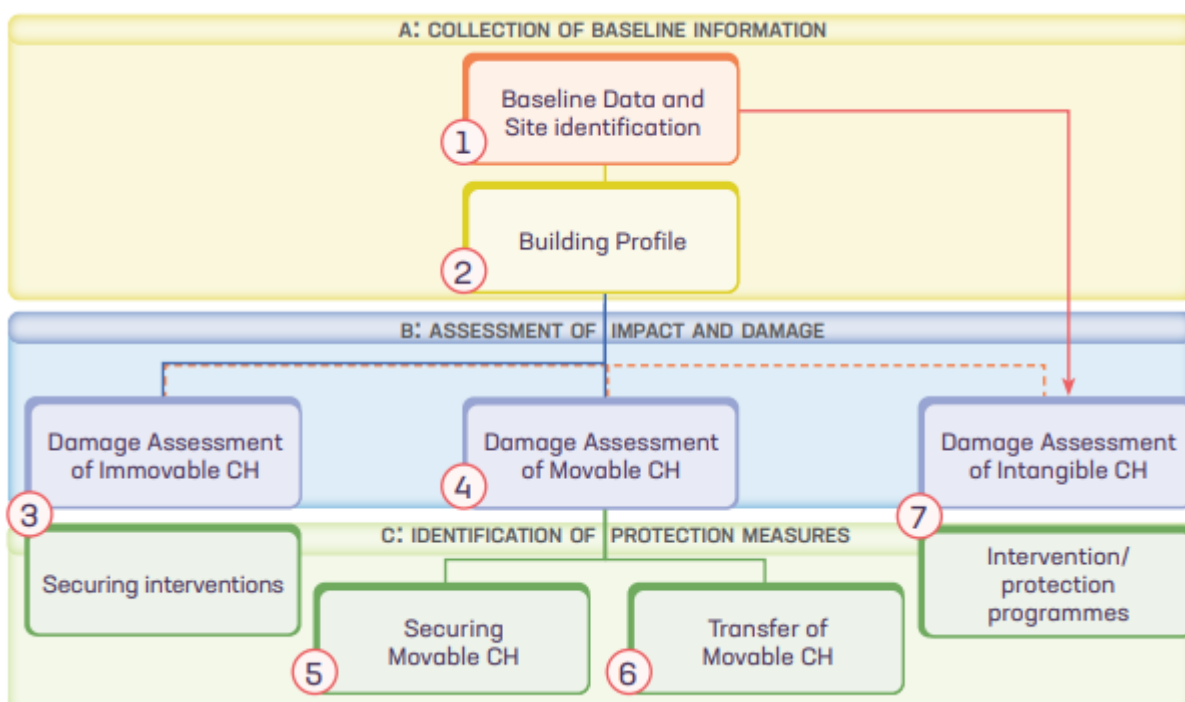
1. collection of basic information;
2. assessment of impact and damage;
3. identification of protective measures to be taken.

Fig. 1 Template and sequence of activities (the red circles indicate the different Templates)

- Immovable cultural heritage: Sheet 1 - Site, Sheet 2 - Building, Sheet 3- Damage assessment and safety action;
- Movable cultural heritage (contained within a "container" building): Sheet 1 - Site, Sheet 2 - Building, Sheet 4- Damage assessment, Sheet 5- Securing and Sheet 6- Relocation;
- Intangible cultural heritage: Sheet 1 - Site, Sheet 2 - Building (optional), Sheet 4 - Damage Assessment (of a movable cultural heritage asset, also optional) and Sheet 7- Damage Assessment and Interventions/Protection Programs.

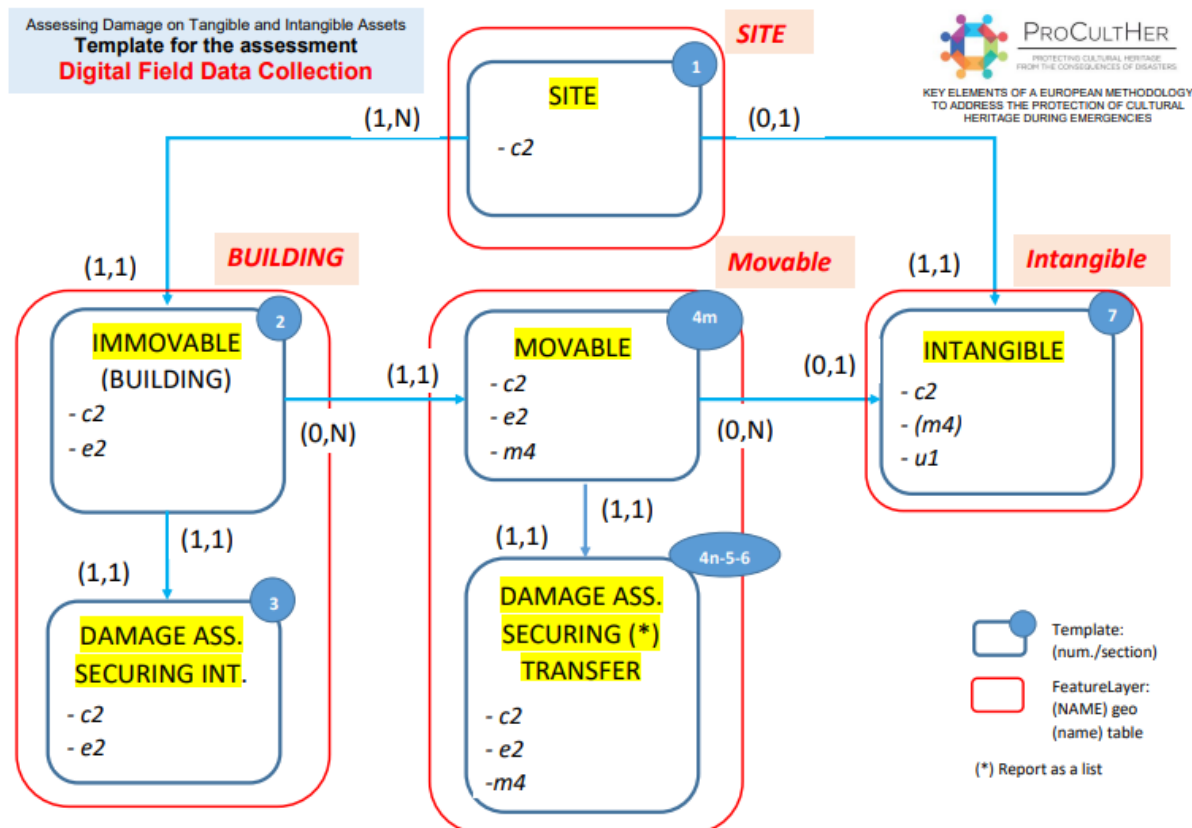
Fig. 2 Logical/conceptual diagram of automated data collection using Survey123 Source: author's concept note

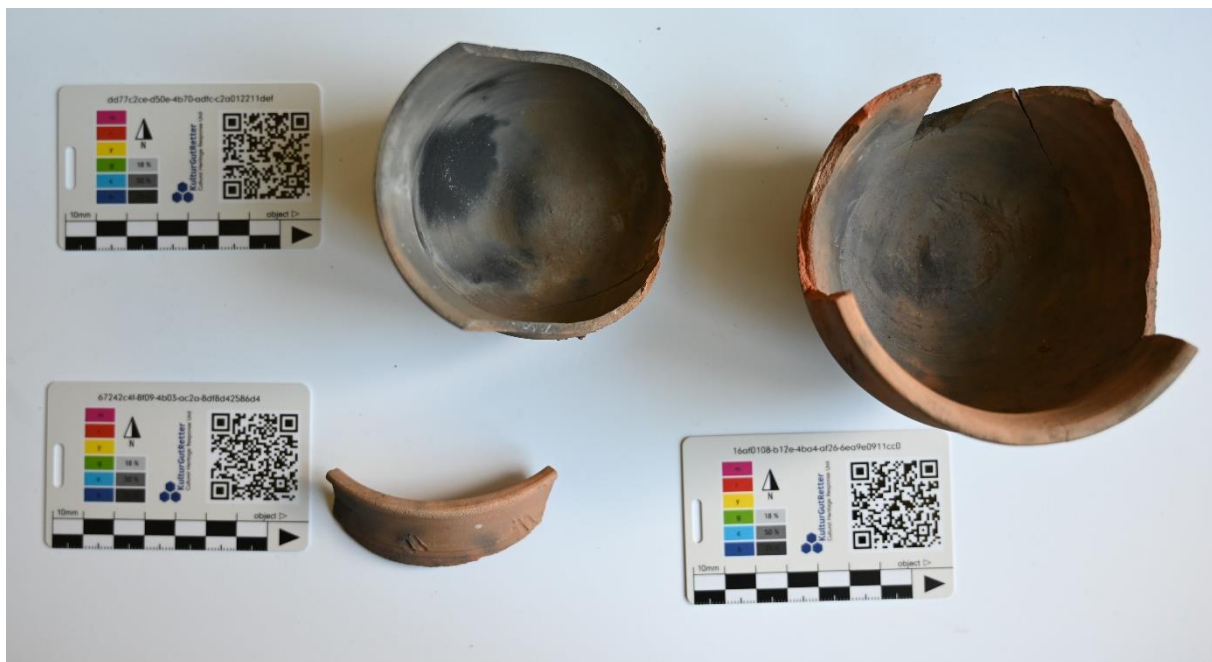
As part of the project, a credit card-sized card was developed that can be attached to any movable cultural asset, thus enriching a photo with a (small) scale and a color table. Moreover, via the imprinted UUID - repeated once in plain text and once in the form of a QR code - the object is directly linked to the corresponding data set, which can be accessed by scanning the QR code in the app. In addition to the content designations, immovable cultural heritage is identified uniquely by UUIDs.

*Examples of movable heritage connected to a UUID via QR code © Eva Götting*

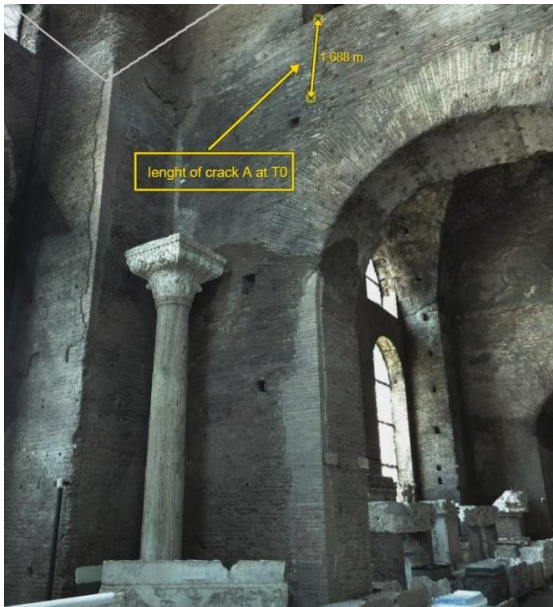
Fig. 1 Terme di Diocleziano (Rome): length of crack A at T0 © Vigili del Fuoco

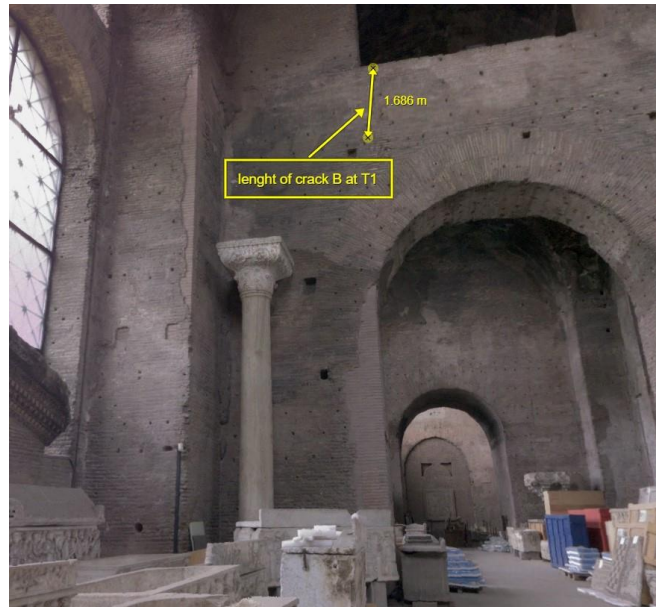
Fig. 2 Terme di Diocleziano (Rome): length of crack A at T1 © Vigili del Fuoco

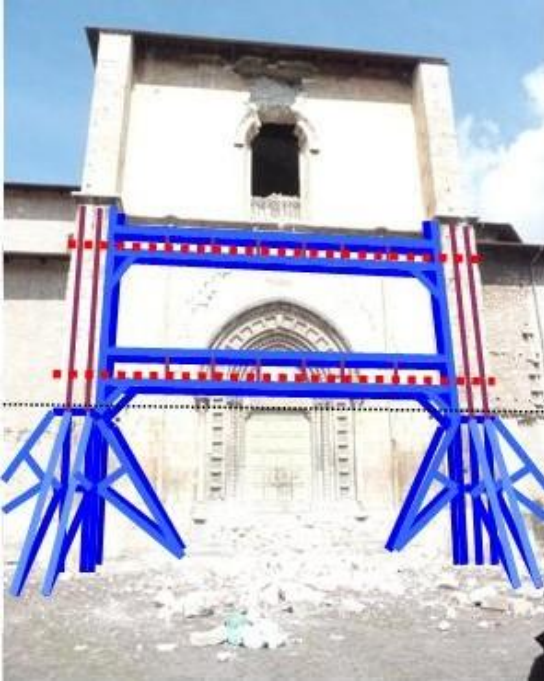
*Fig. 3 Church of San Domenico (L'Aquila): design of provisional works © Vigili del Fuoco*

The first case was triggered by the well-established civil protection cooperation with CNVVF and Ministry of Culture in designing and installing provisional works for historical and cultural buildings damaged by earthquakes (to leverage on both the cultural heritage experts' deep knowledge of the damaged buildings and the expertise of CNVVF in designing and installing provisional works). In the 2009 L'Aquila earthquake the design of the provisional works was agreed upon through the exchange of reference photos, which, although apparently a simple operation, supported the remote cooperation on installation of works very efficiently. (Fig. 3 and Fig. 4).

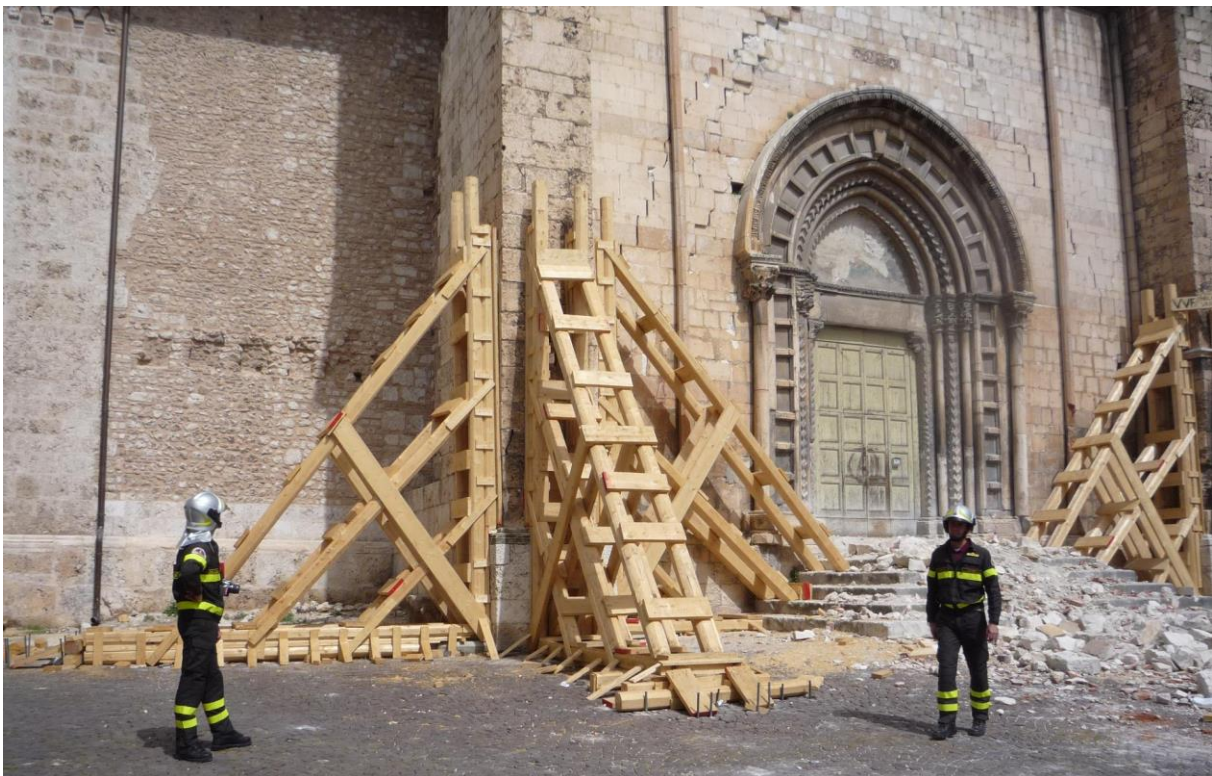
*Fig. 4 Church of San Domenico (L'Aquila): Implemented provisional works © Vigili del Fuoco*

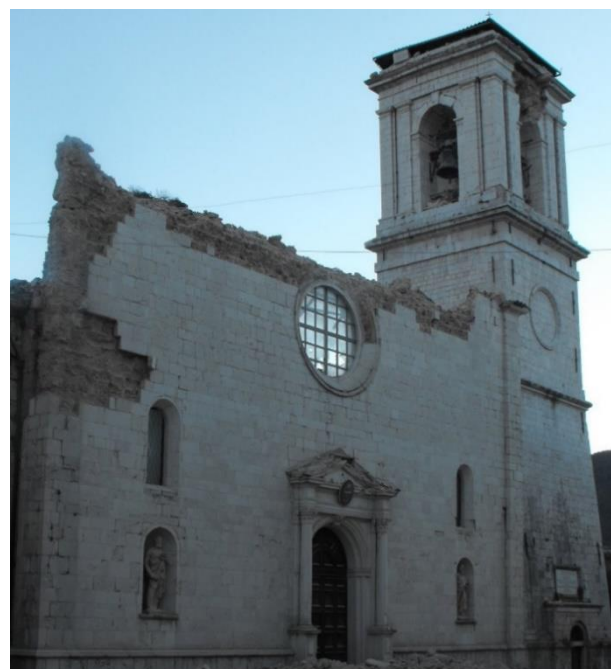
Fig. 6 Santa Maria Argentea (Norcia): facade damages © Vigili del Fuoco

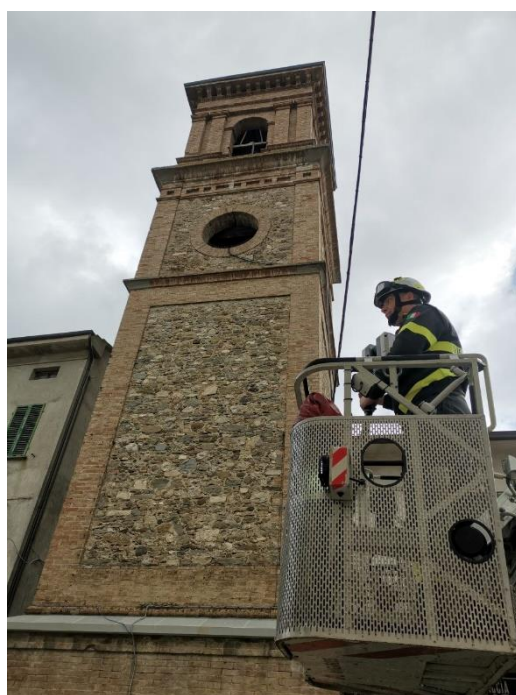
*Fig. 10 Acquisition of bell tower point cloud, Pierantonio (Perugia)  
© Vigili del Fuoco*

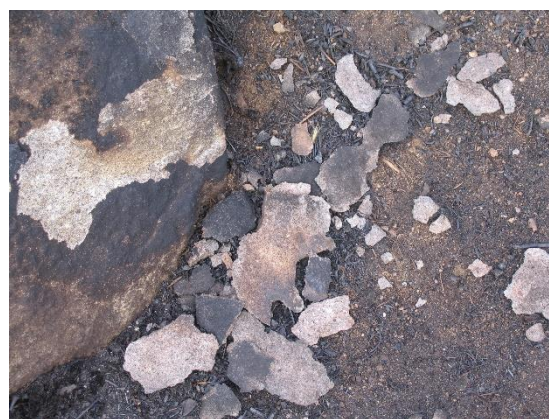
*Damage to granite rock due to high temperatures, forest fire in archaeological area. Cerro del Berrueco, Salamanca, 2017 © UGRECYL*

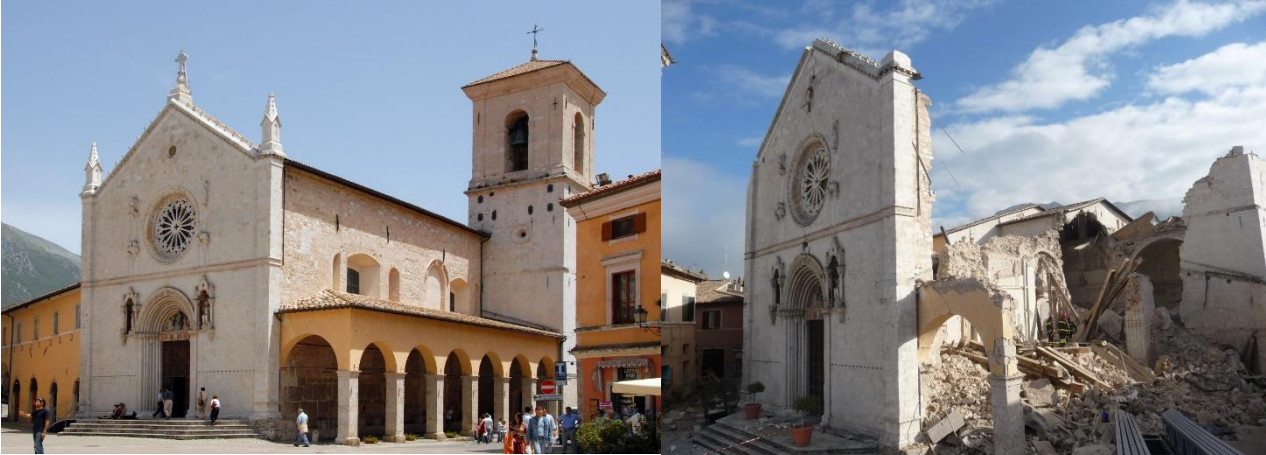
*Left: The Basilica of San Benedetto in Norcia before and after the seism of 30 October 2016; right: the rubble masonry literally crumbled, leaving inside the Basilica a four meters high rubble front © MiC*

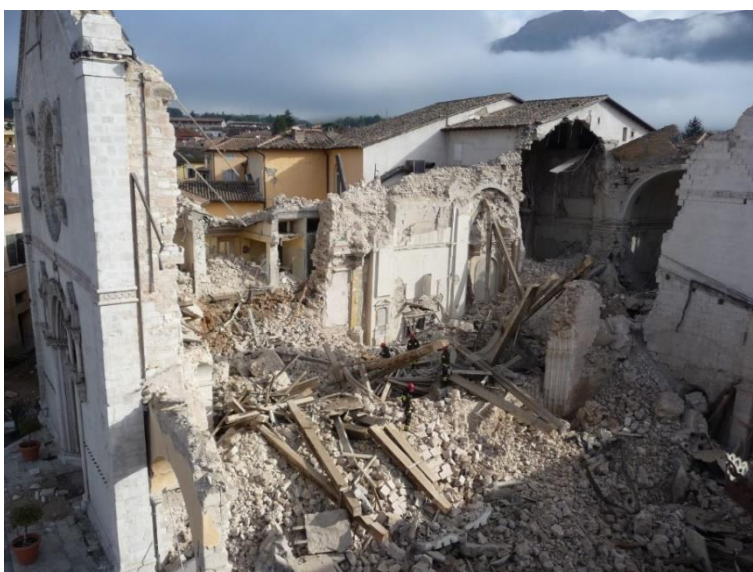
*Internal view of the Basilica of San Benedetto in Norcia after the seism of 30 October 2016 © MiC*

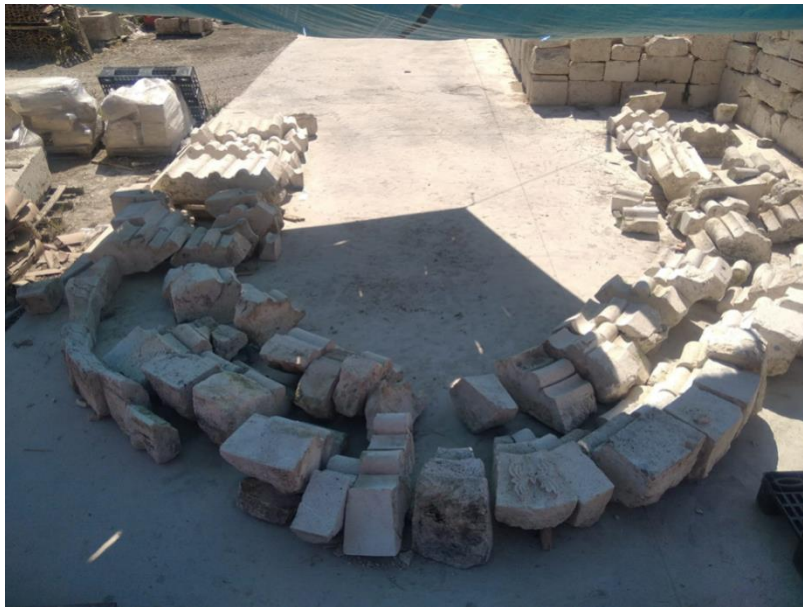
*The Gothic arch reassembled at the St. Scholastica site with a view to its relocation © MiC*

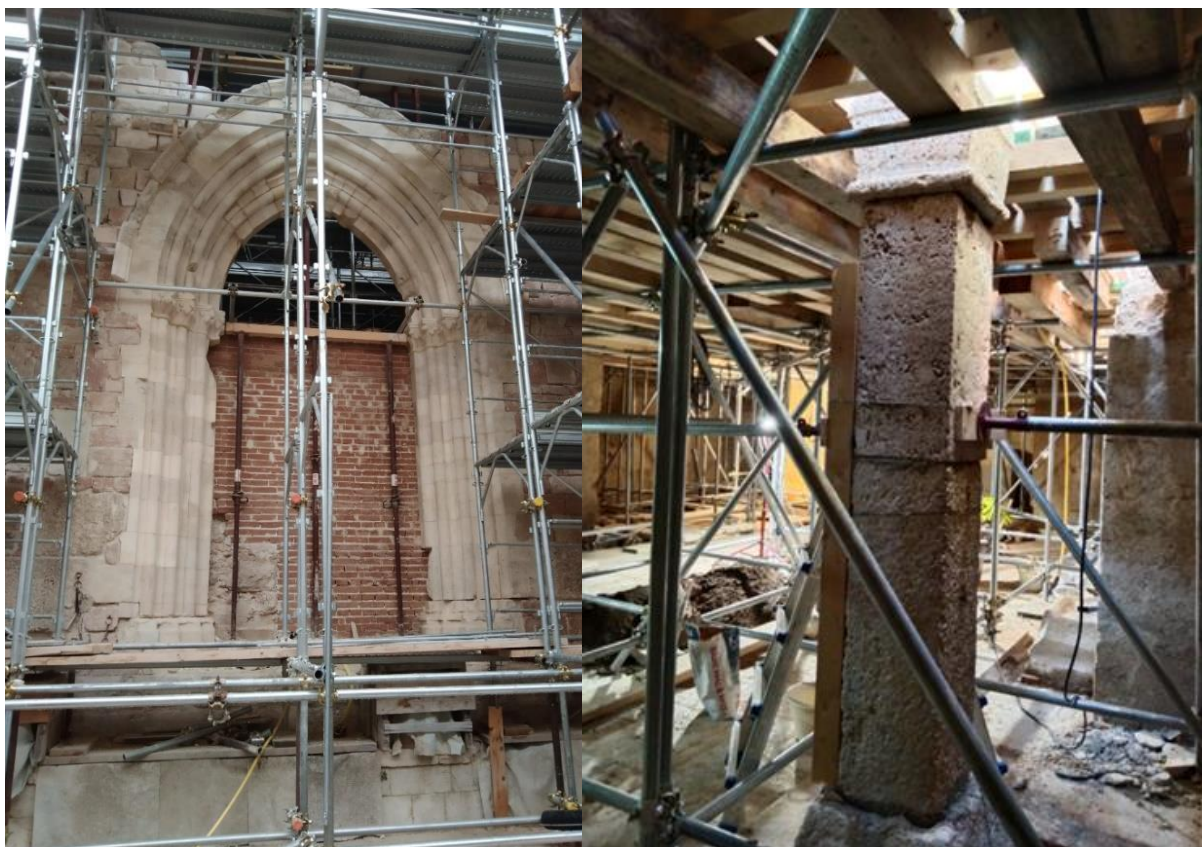
*Left: The Gothic arch repositioned in the wall of the Basilica; right: one of the pillars repositioned in the crypt © MiC*

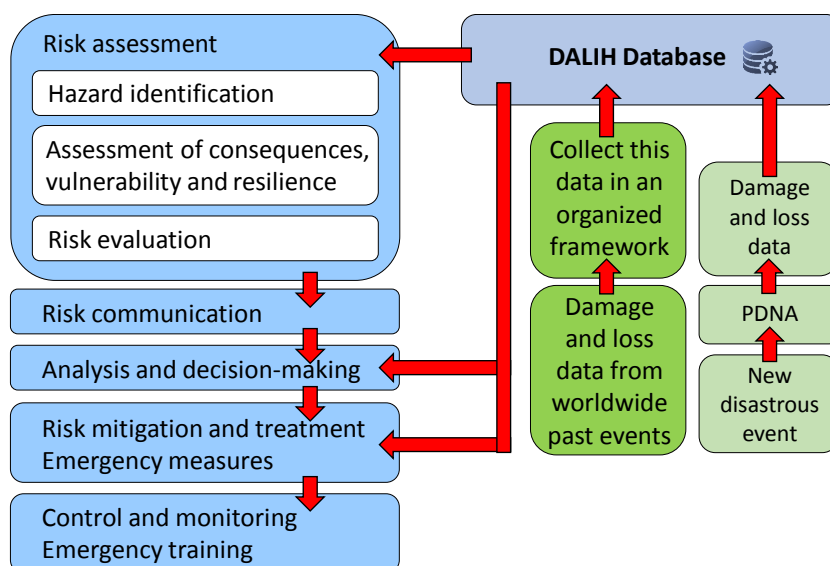
Fig. 2 The DALIH database within the risk management cycle for cultural heritage
