# **A framework for data & information exchange for seismic risk harmonization in the Greece- Türkiye Cross Border Area**

## **Deliverable No: D3.2**

**WP3: Joint Seismic Risk Assessment of School Buildings**

**T3.2: Joint assessment of seismic risk in the Greece- Türkiye CBA (school  
buildings in the pilot sites)**

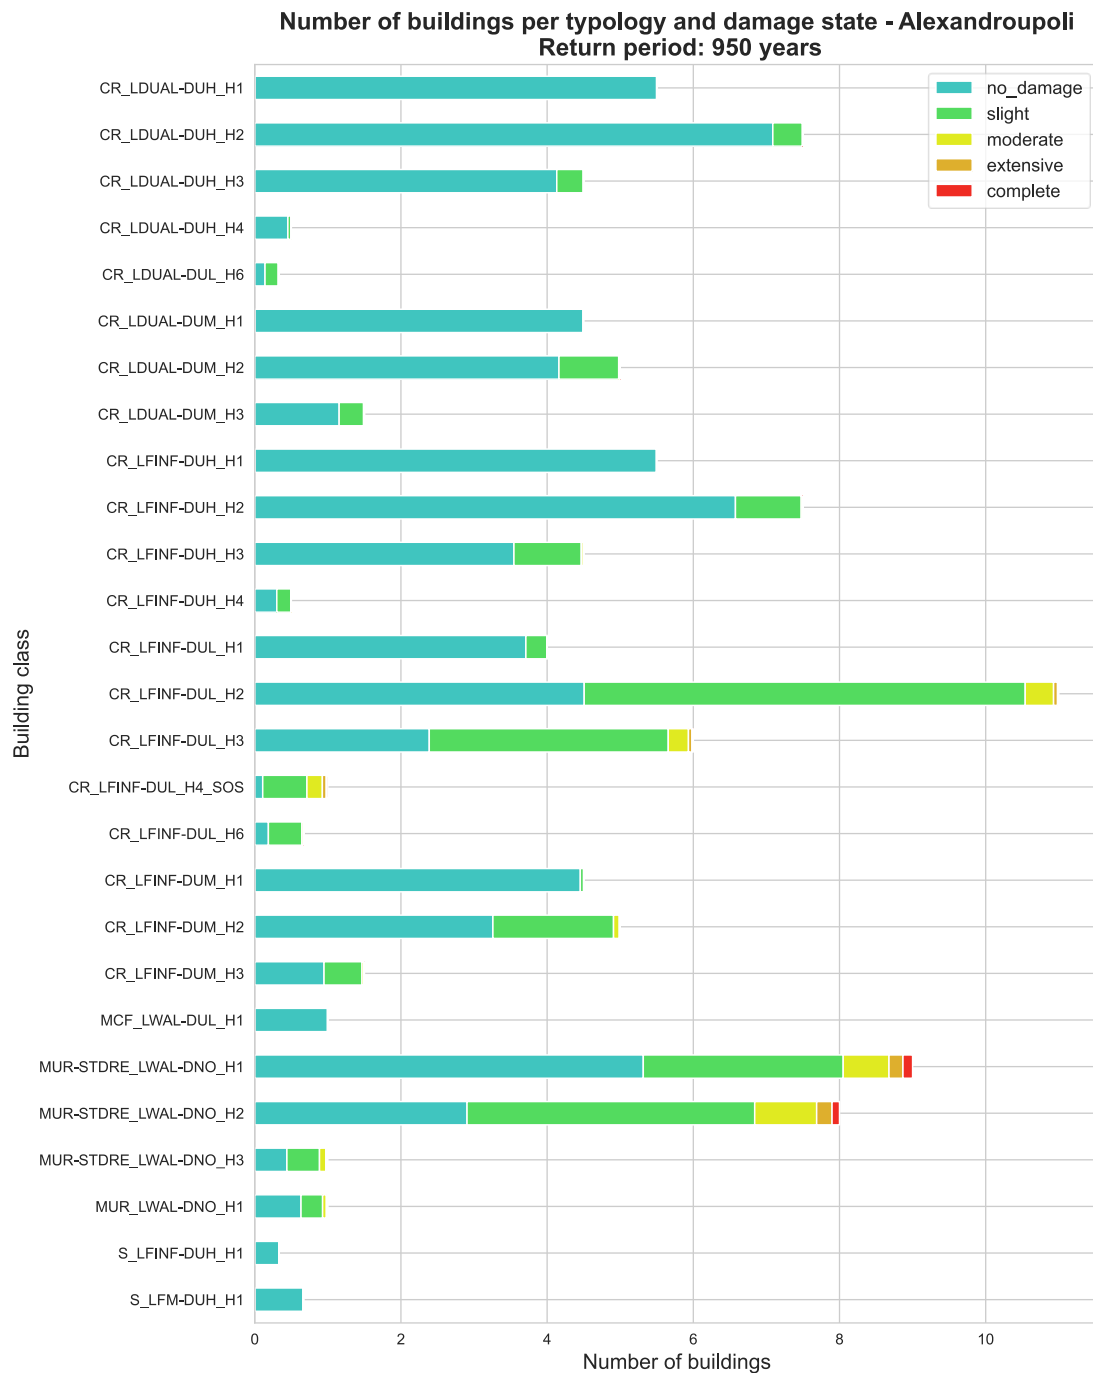
**Figure 54. Number of school buildings per GEM typology and damage state in the city of Alexandroupolis for PSHA scenario with  $T_m=950$  yrs.**

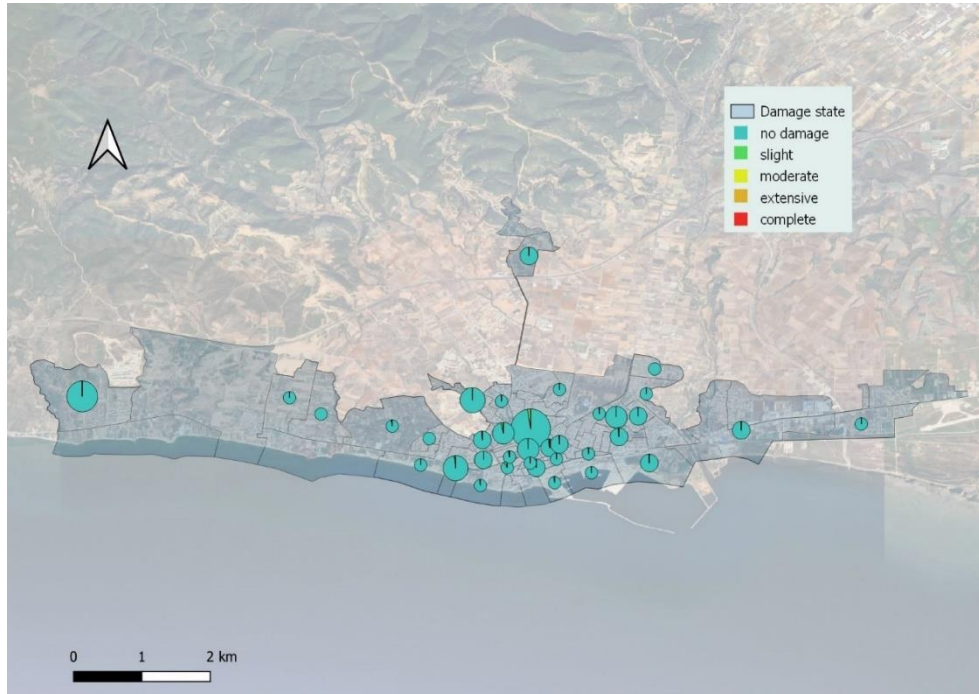
Figure 57. Spatial damage state distribution for school buildings in Alexandroupolis for PSHA scenario with  $T_m=100$  yrs.

Figure 58. Spatial damage state distribution for school buildings in Alexandroupolis for PSHA scenario with  $T_m=475$  yrs.

Figure 59. Spatial damage state distribution for school buildings in Alexandroupolis for PSHA scenario with  $T_m=950$  yrs.

The spatial damage state distribution for school buildings in Alexandroupolis for the three PSHA scenarios (mean return periods of  $T_m=100$ , 475 and 950 years) are presented in Figures 57-59.

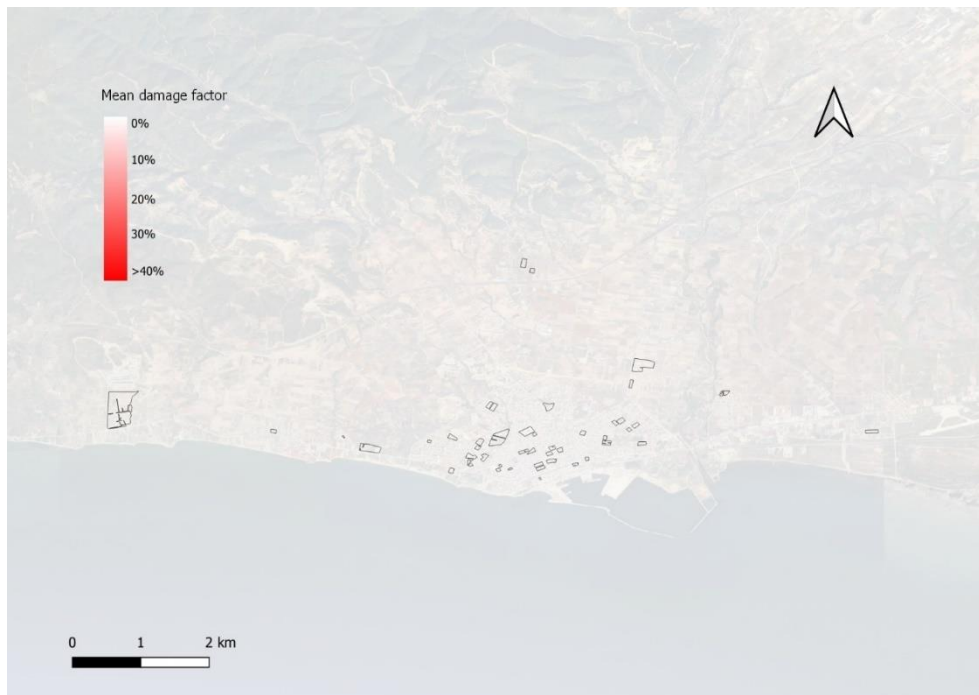
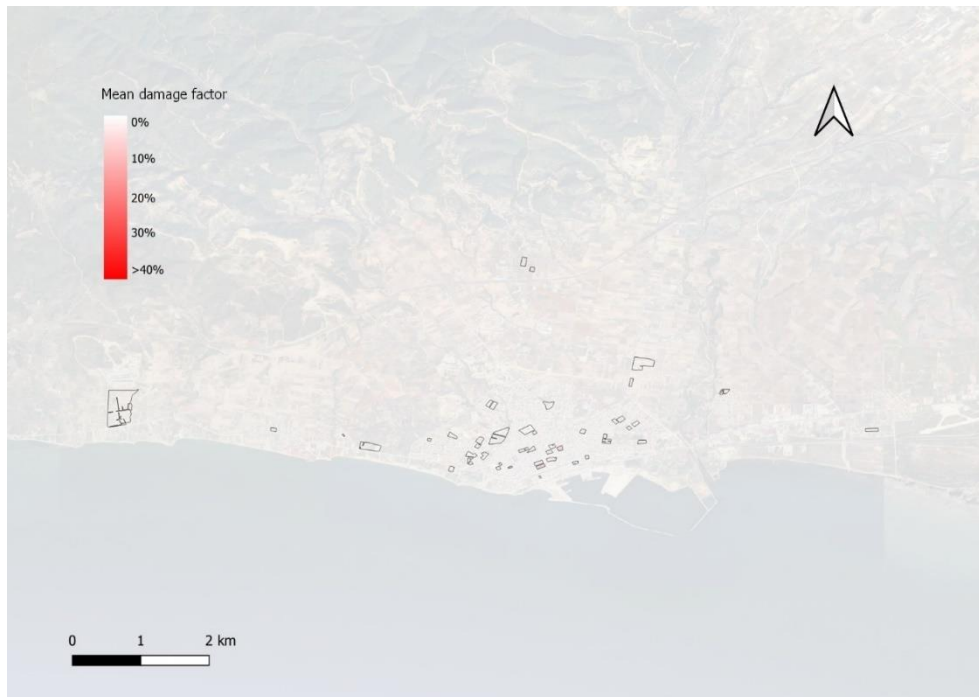
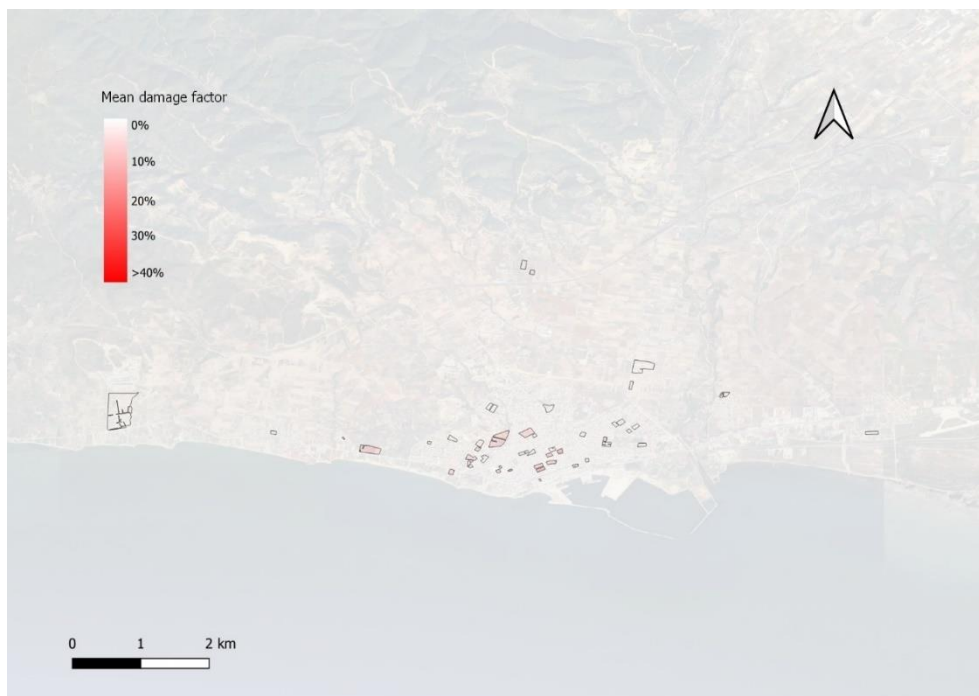
**Figure 62. Spatial mean damage factor distribution for school buildings in Alexandroupolis for PSHA scenario with  $T_m=100$  yrs.**

**Figure 63. Spatial mean damage factor distribution for school buildings in Alexandroupolis for PSHA scenario with  $T_m=475$  yrs.**

**Figure 64. Spatial mean damage factor distribution for school buildings in Alexandroupolis for PSHA scenario with  $T_m=950$  yrs.**

Finally, the spatial mean damage factor distribution for school buildings in Alexandroupolis for the three PSHA scenarios (mean return periods of  $T_m=100$ , 475 and 950 years) are presented in Figures 62-64.

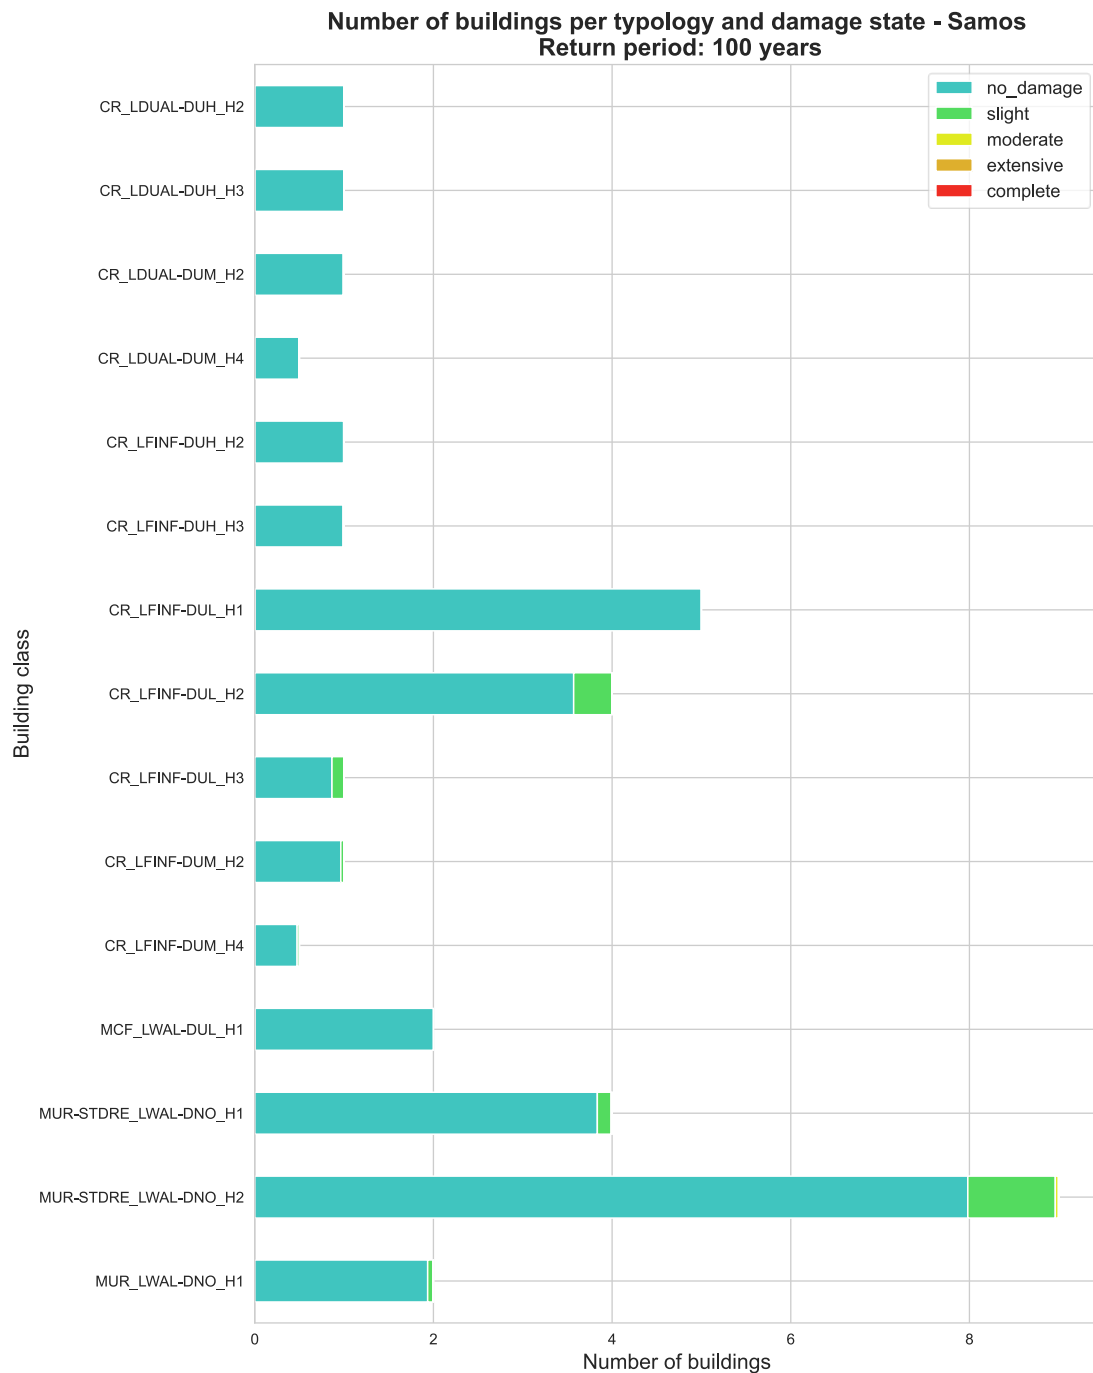
**Figure 84. Number of school buildings per GEM typology and damage state in the city of Samos for PSHA scenario with  $T_m=100$  yrs.**

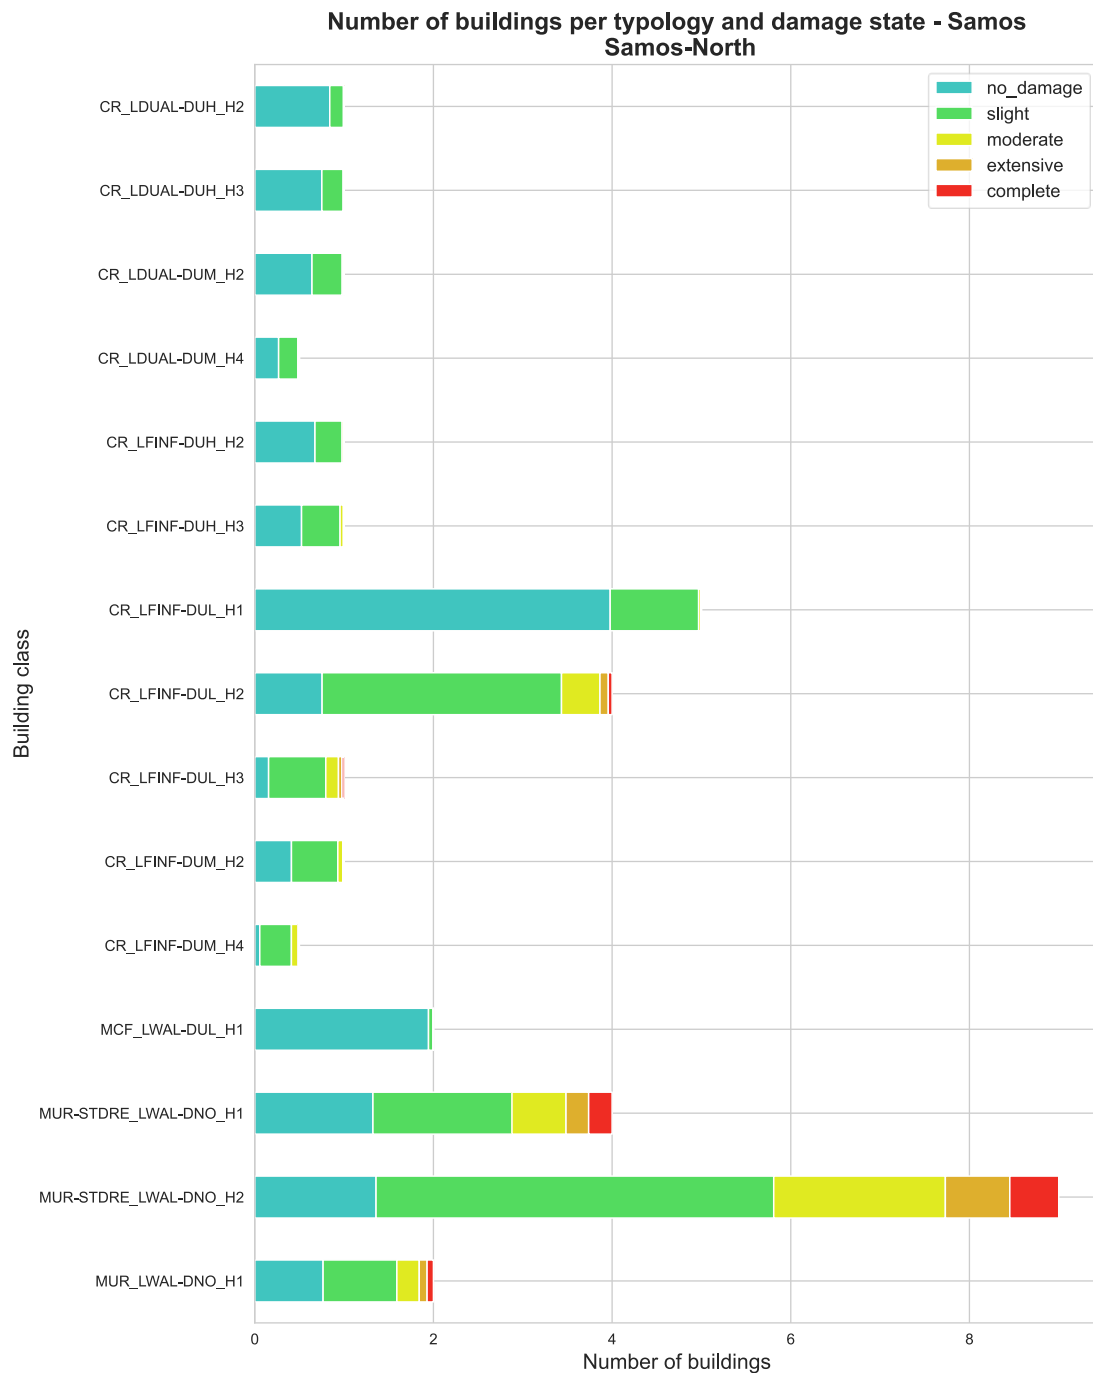
**Figure 87. Number of school buildings per GEM typology and damage state in the city of Samos for the DSHA scenario of the Samos-North fault.**

The corresponding figures for the two deterministic seismic hazard (DSHA) scenarios, namely Samos-North and Samos-Validation, are presented in Figure 87 and Figure 88, respectively.

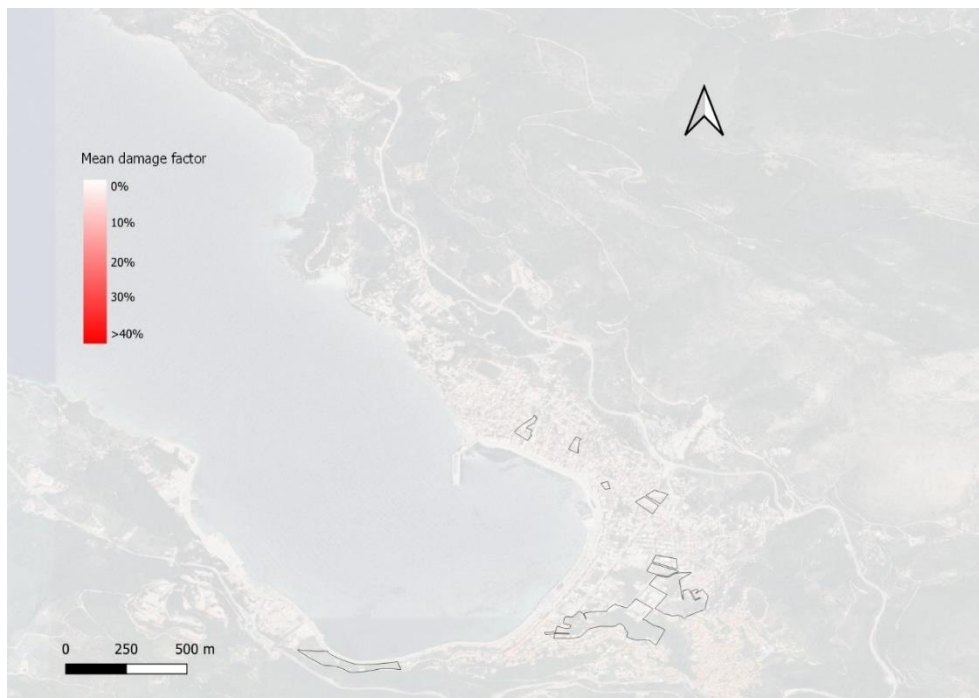
Figure 94. Spatial mean damage factor distribution for school buildings in Samos for PSHA scenario with  $T_m=100$  yrs

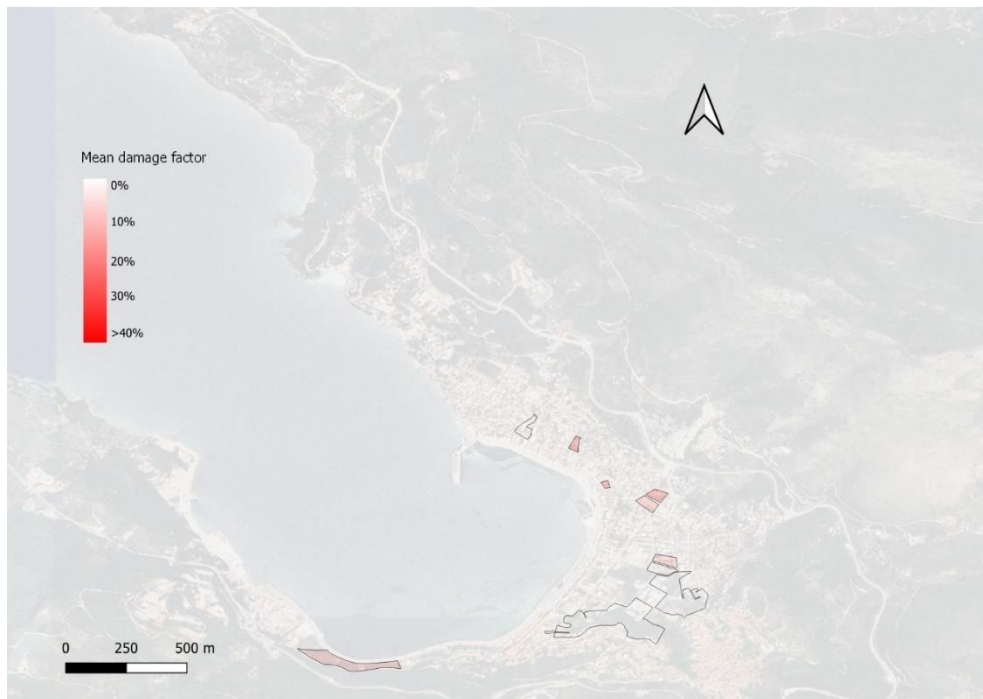
**Figure 95. Spatial mean damage factor distribution for school buildings in Samos for PSHA scenario with  $T_m=475$  yrs**

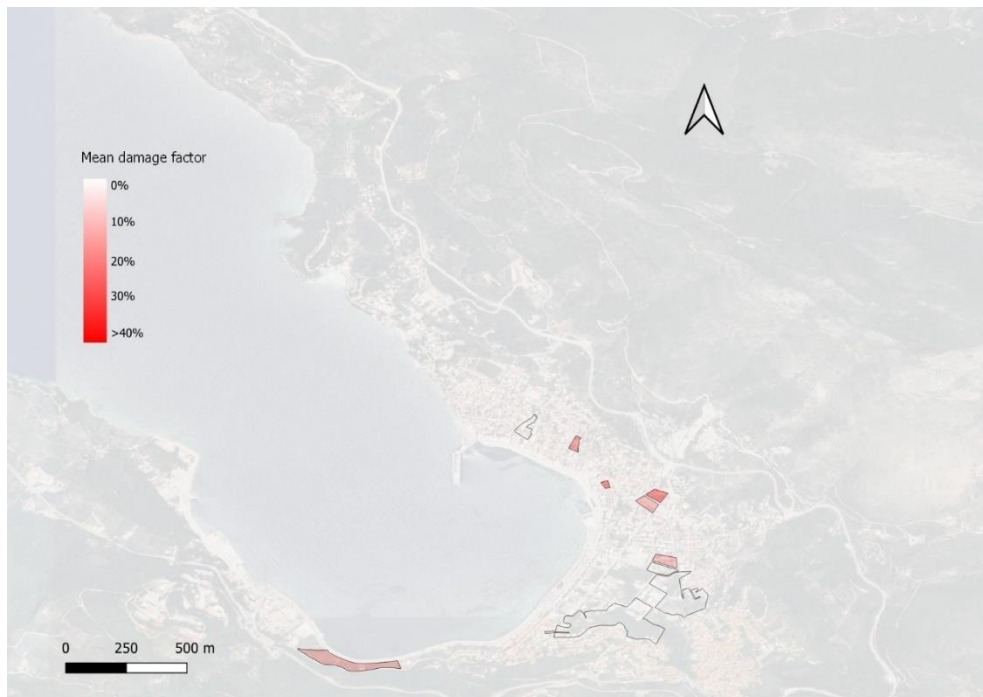
**Figure 96. Spatial mean damage factor distribution for school buildings in Samos for PSHA scenario with  $T_m=950$  yrs**

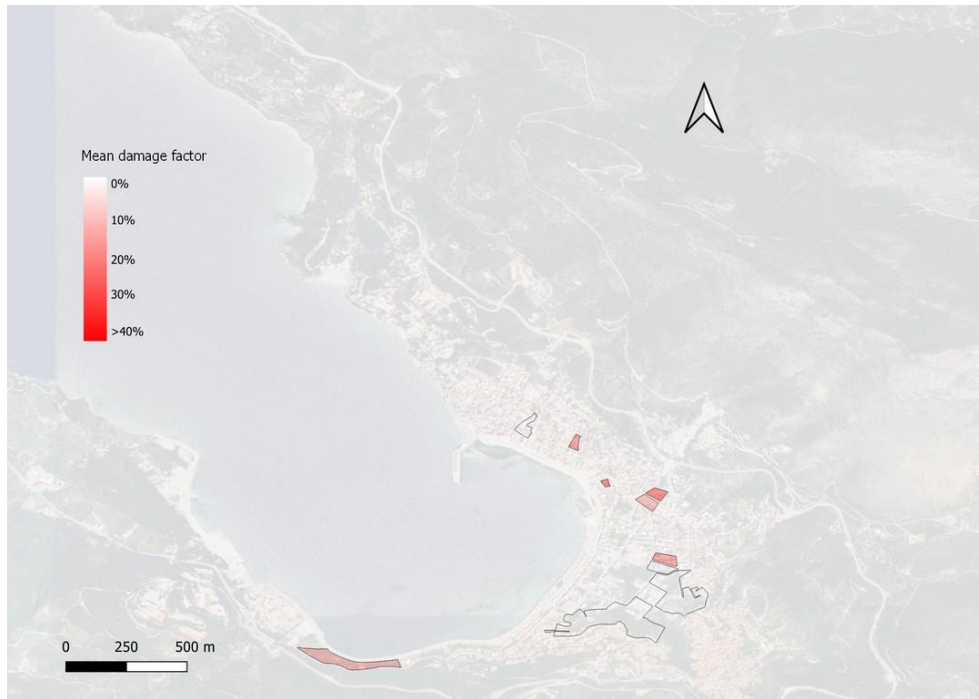
**Figure 97. Spatial mean damage factor distribution for school buildings in Samos for the DSHA scenario of the Samos-North fault.**

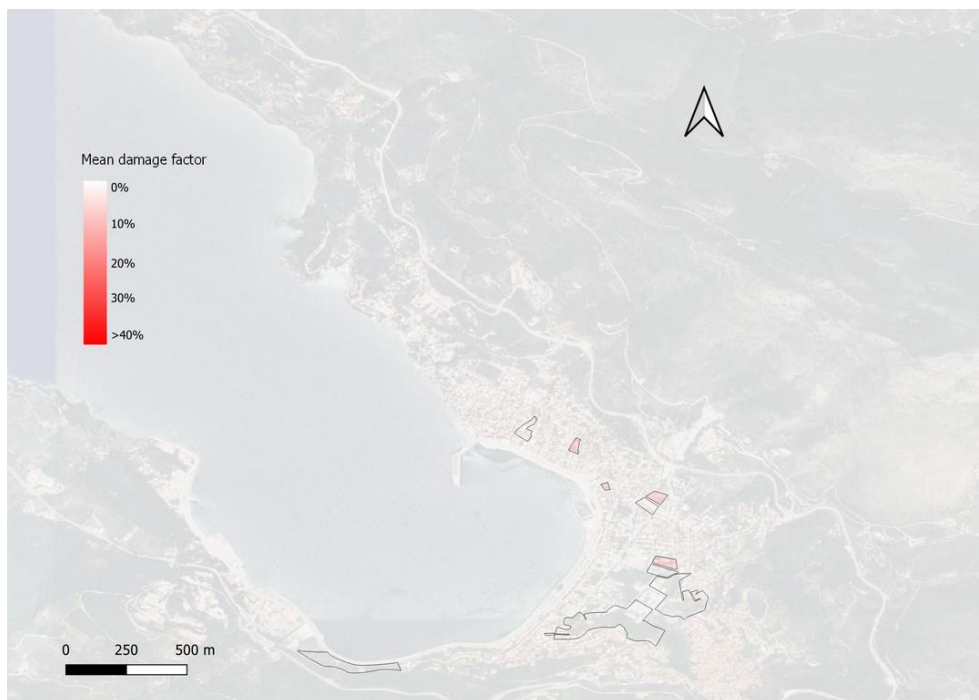
**Figure 98. Spatial mean damage factor distribution for school buildings in Samos for the Samos-Validation DSHA scenario.**
